Experience, solutions and development of operating geothermal ESP-systems in the southern Germany molasse reservoir.

Dipl.-Ing. Christoph Harden

High-Efficiency Geothermal Production Pumps Forum II

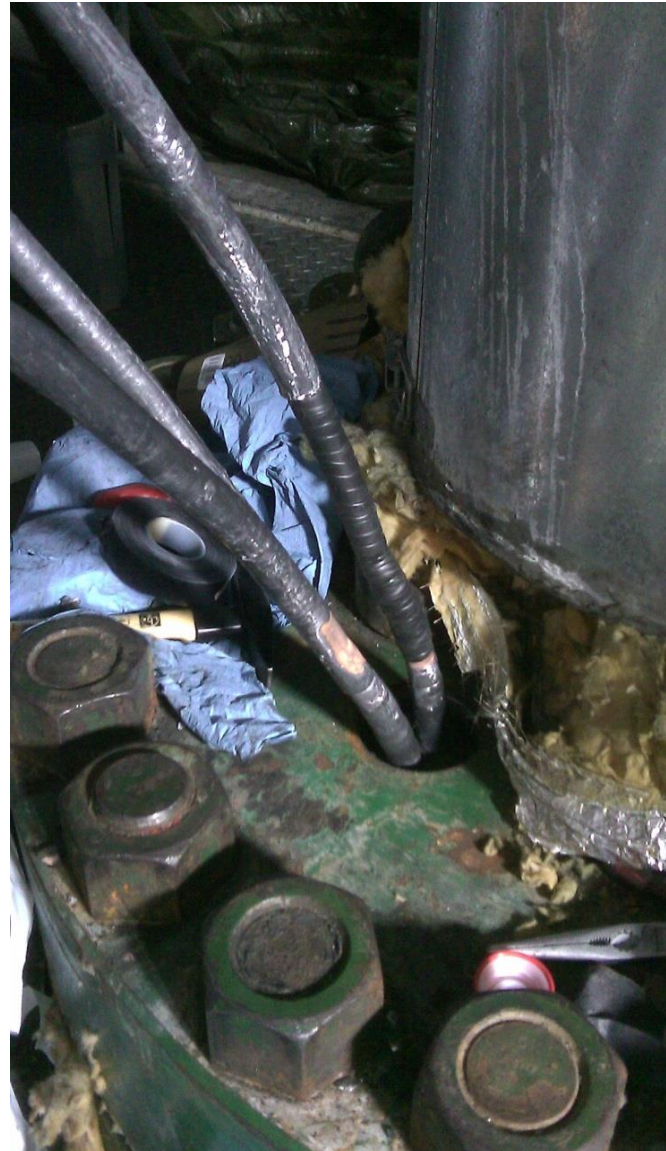
Galling at „well head“
(penetrator)

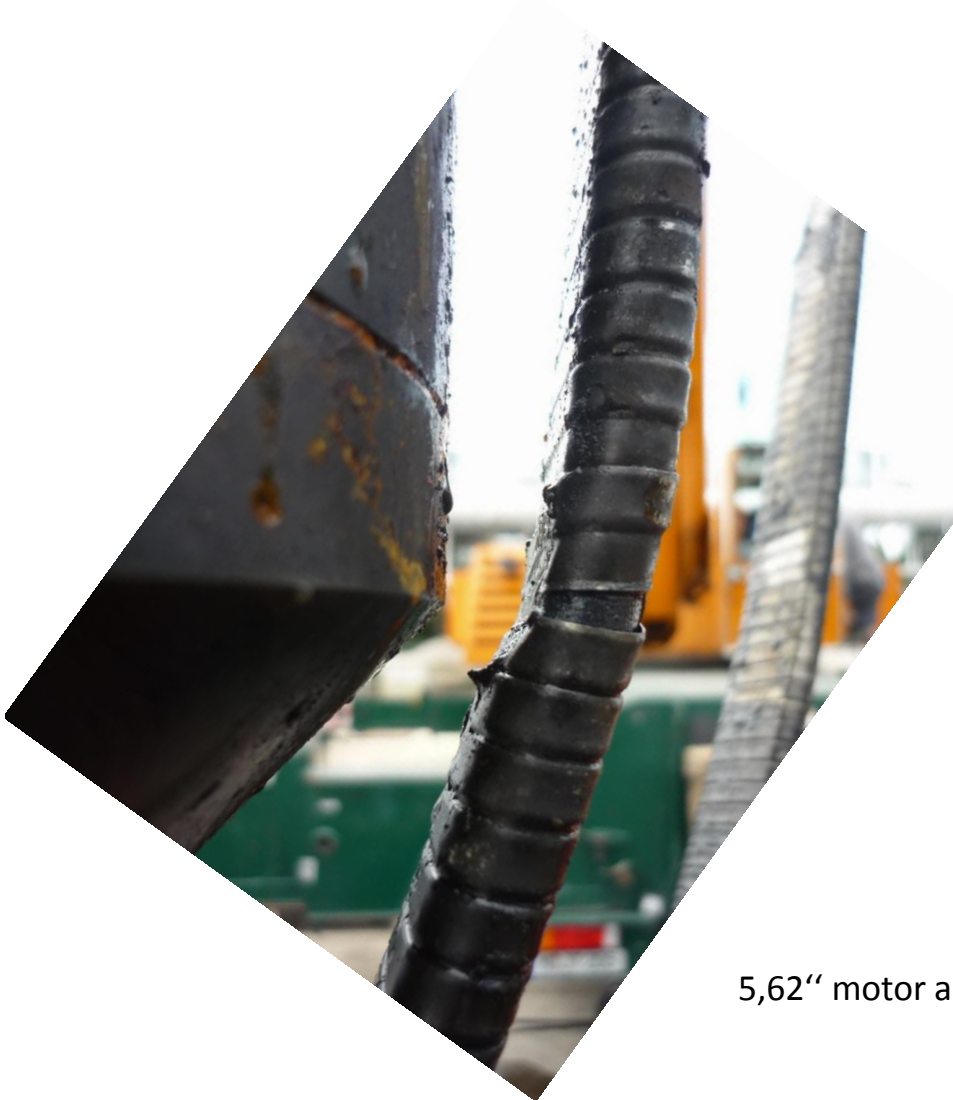
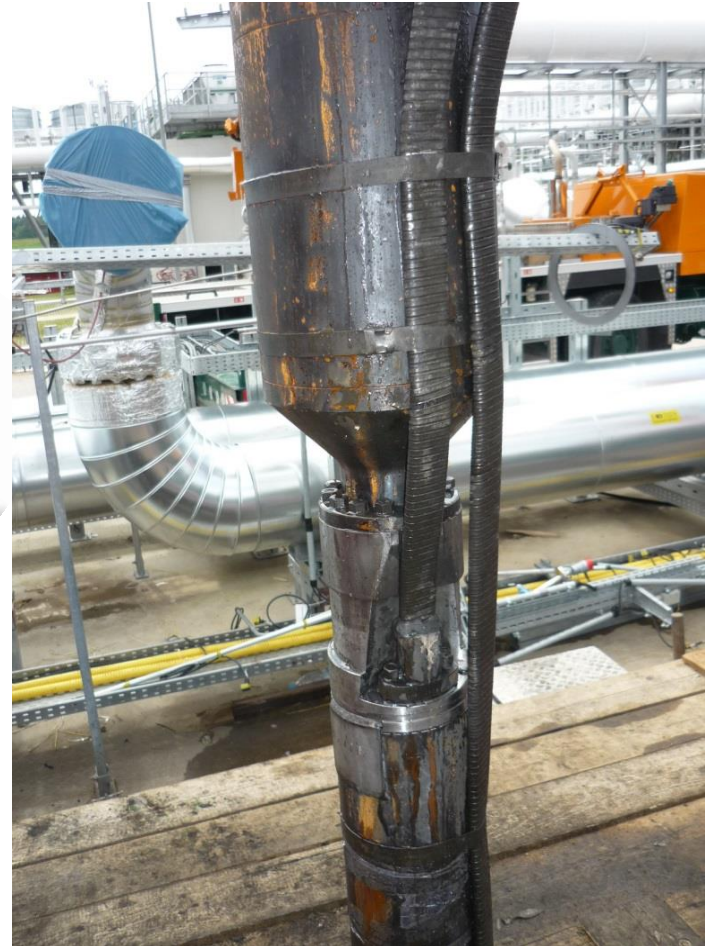
5,62" motor and 11" seal installed in 13 5/8" casing.

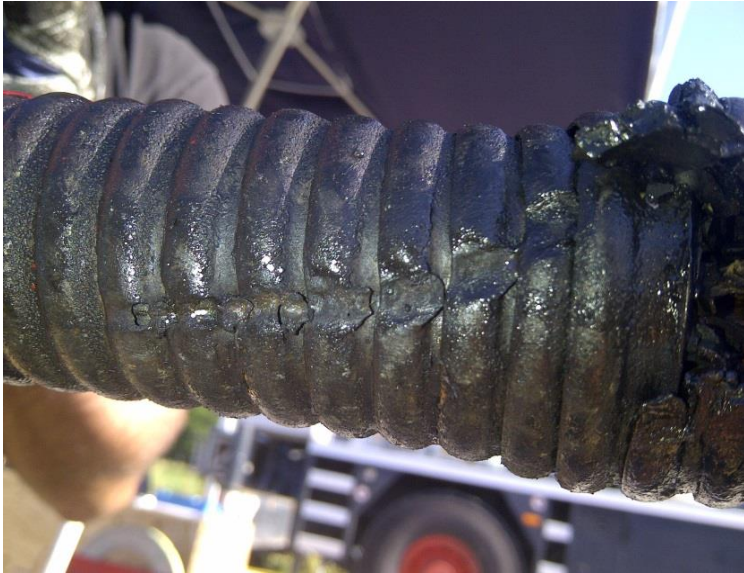
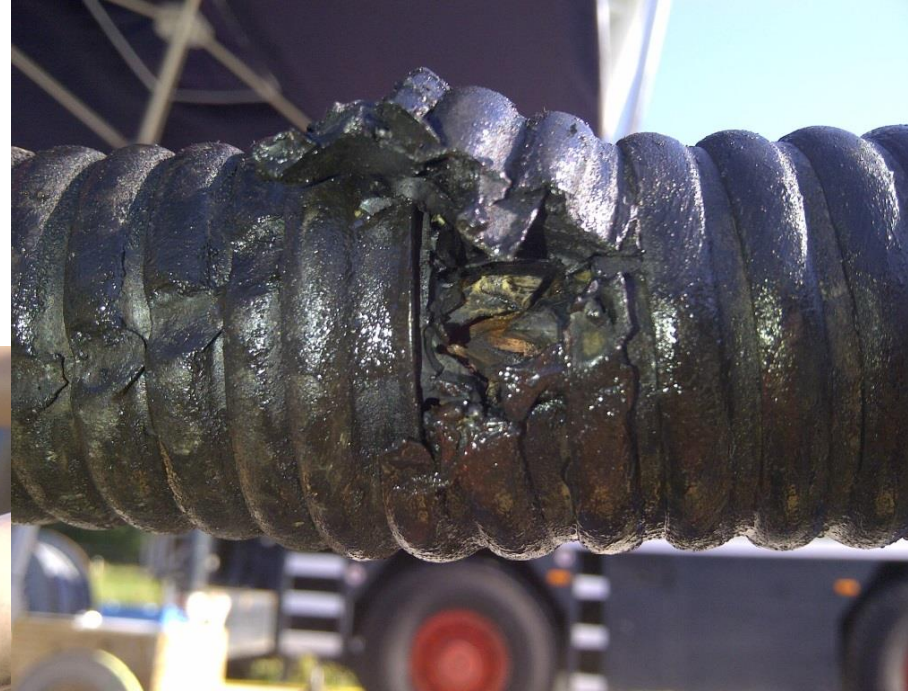
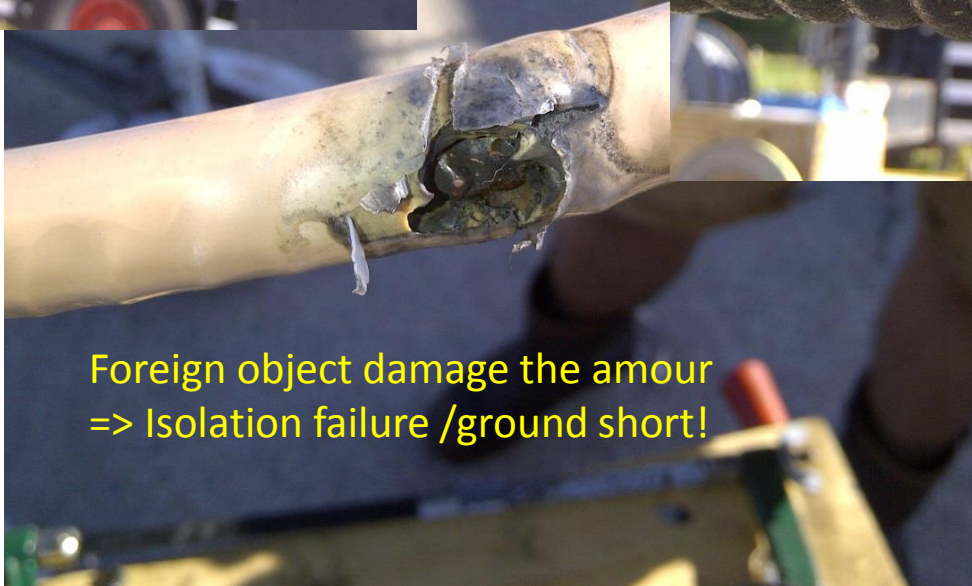
Foreign object damage the amour
=> Isolation failure /ground short!

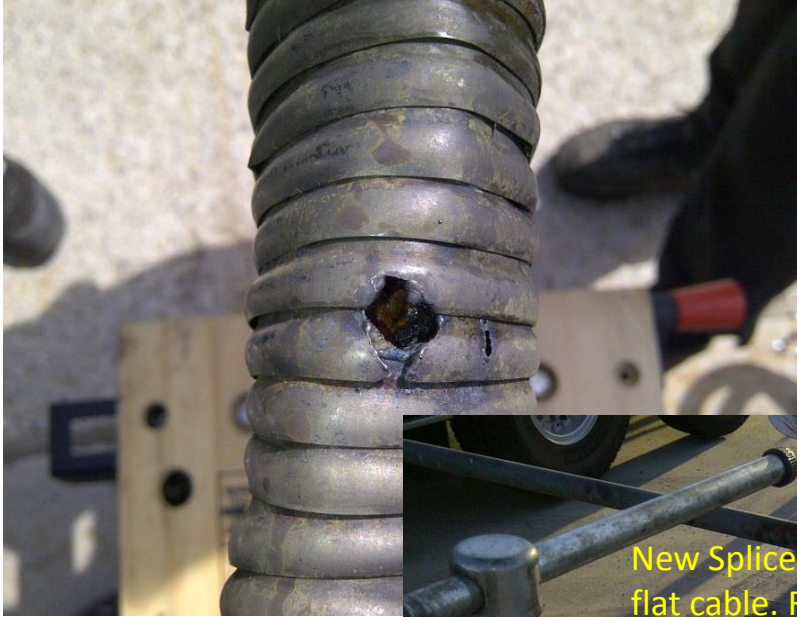
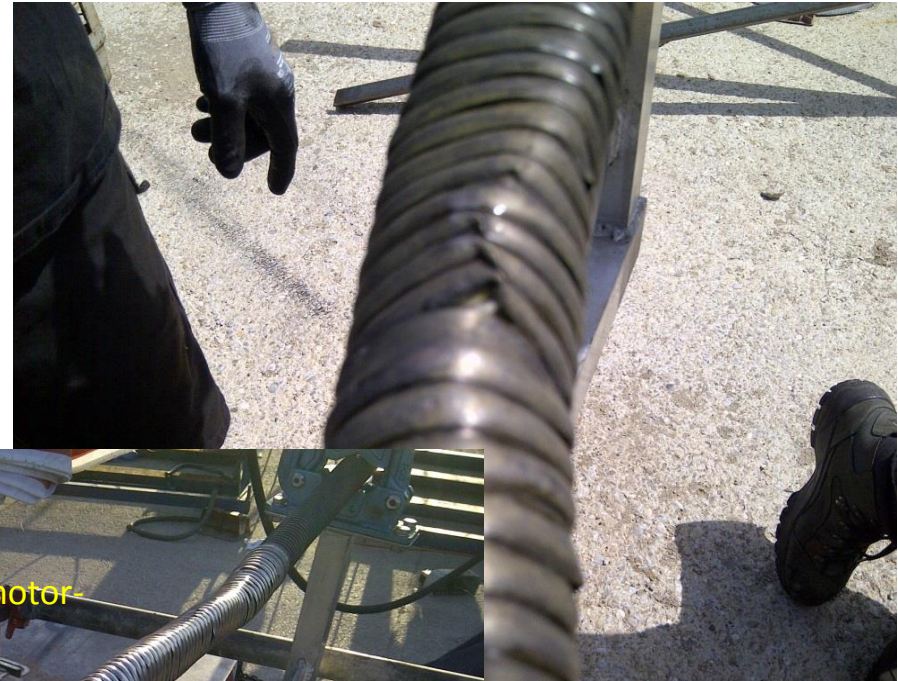
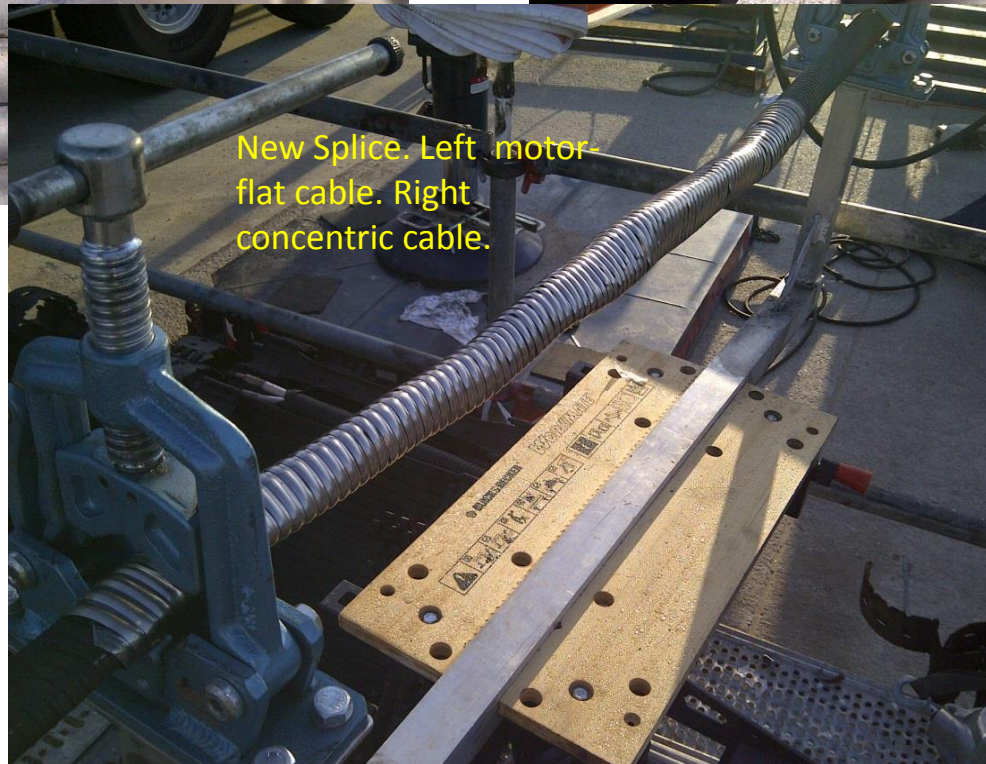
During run in=> armour of splice is damaged & internal failure in electrics. Short to ground!

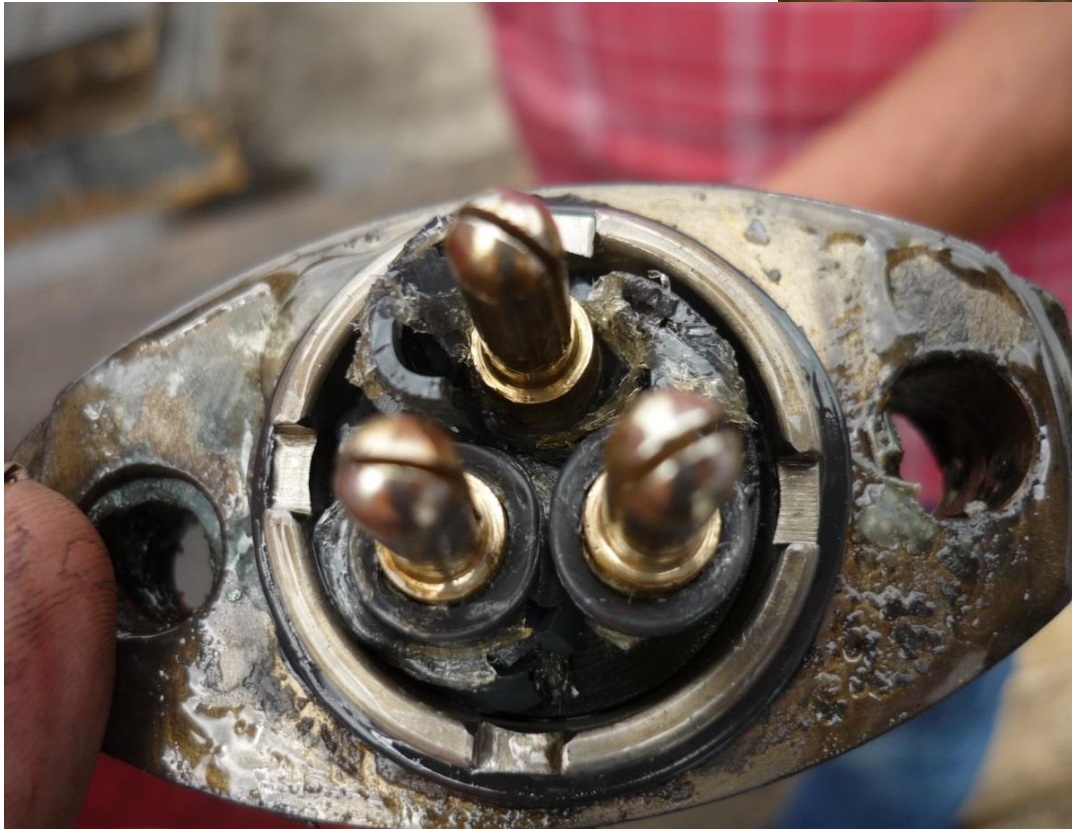
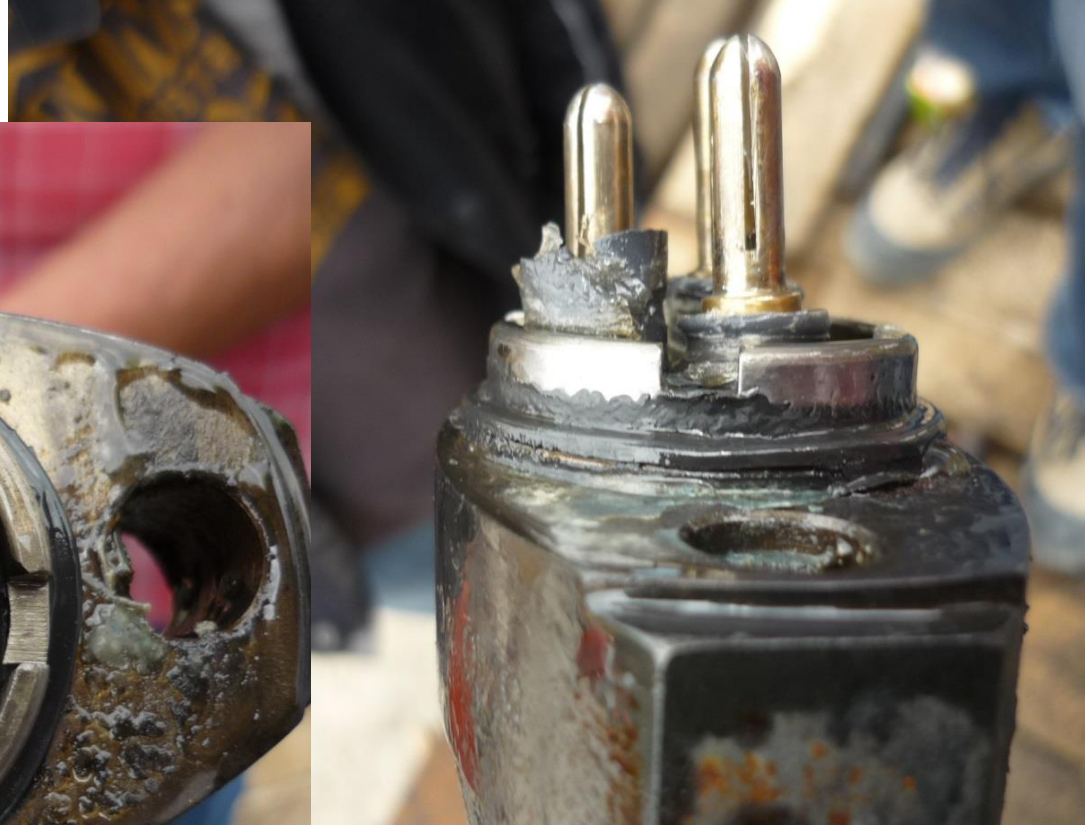
Missing axial fixing at the connector pins!

Rubber swelling. O-rings squared. Thermal influence

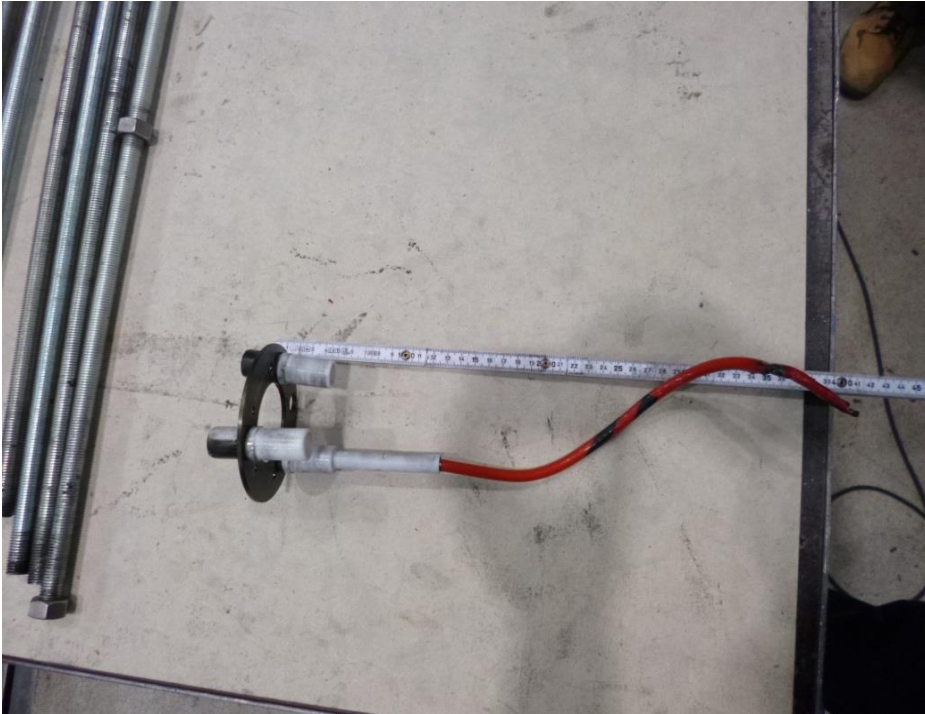
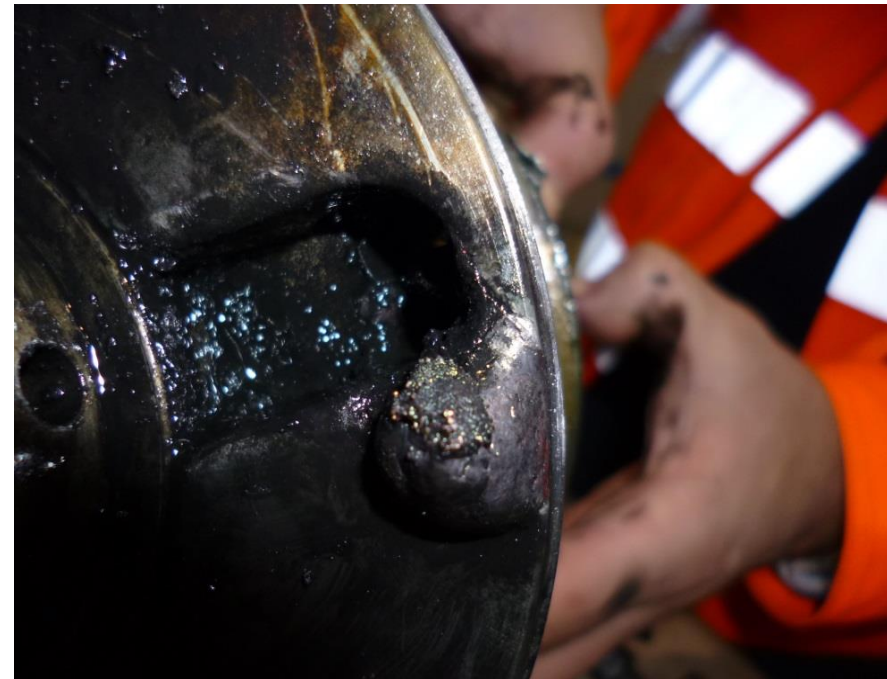
During Operation the isolation decrease and the partial discharge increase. Severe contamination of the motor oil.

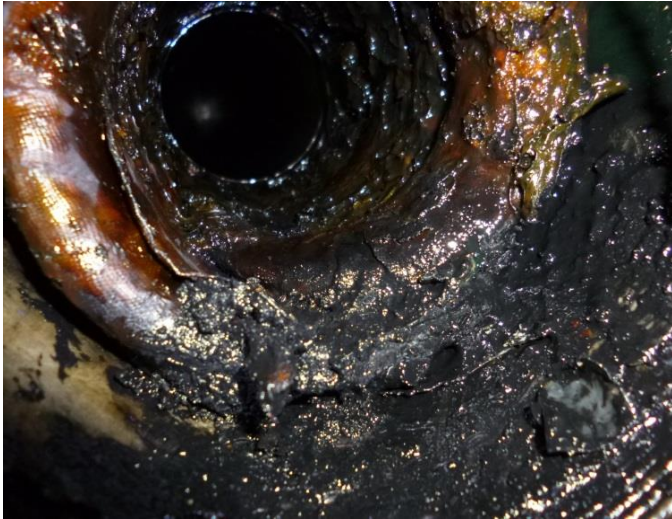
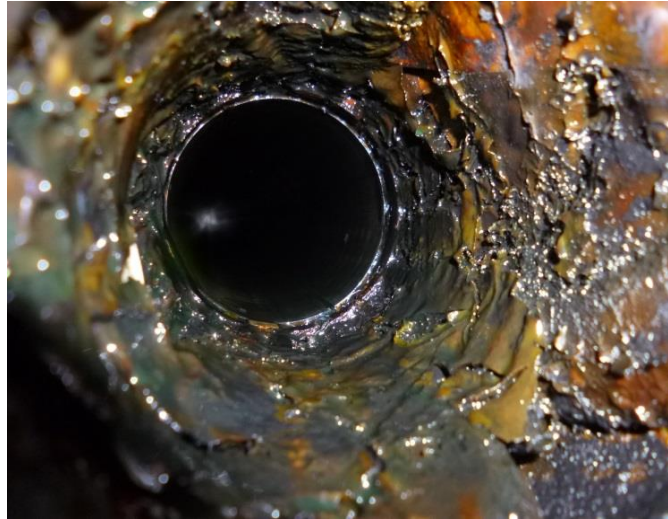
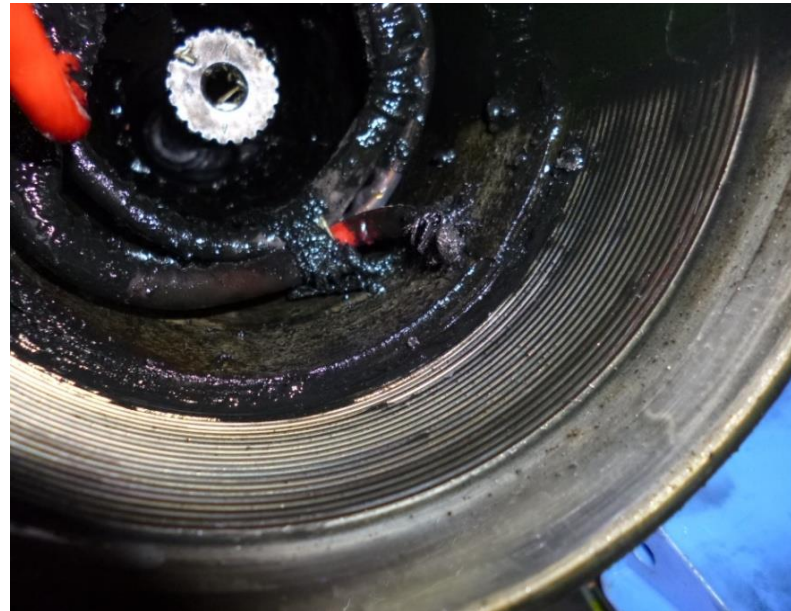
Severe oil contamination with carbon and copper. Short at the end windings.

Due to a unbalanced load 2 phases were overloaded. 1 phase missing. Short at floating-Y-point

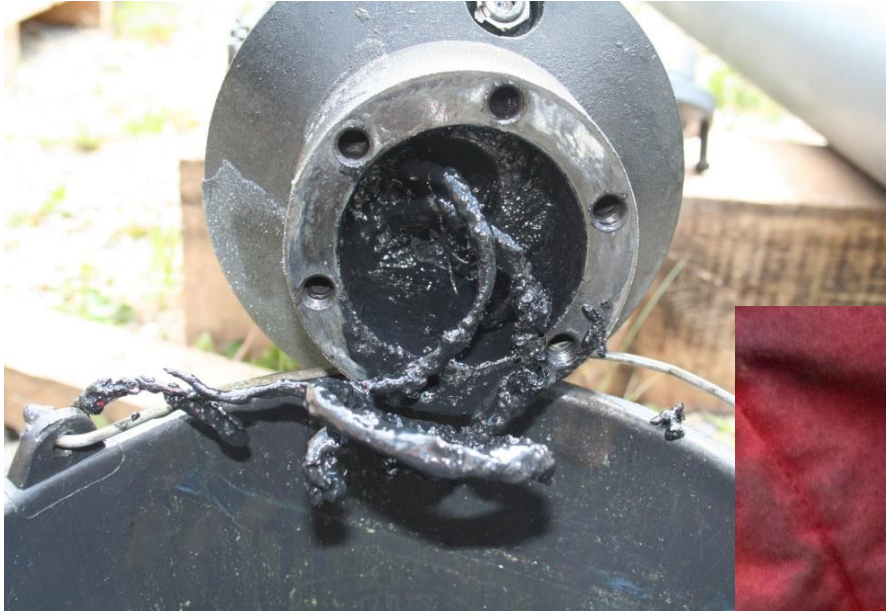
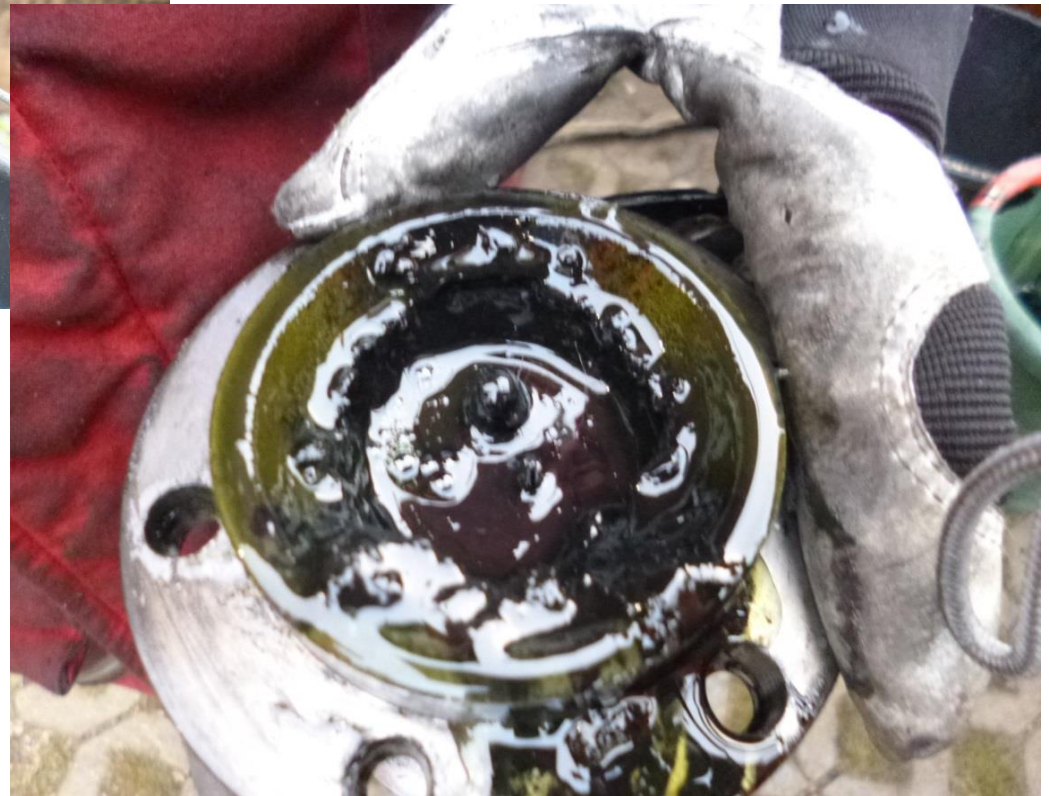
Isolation failure => damaged sensor!

Sediments of carbon and residue of thermal alteration deposits connect the ground an Y point potential. Ground short!

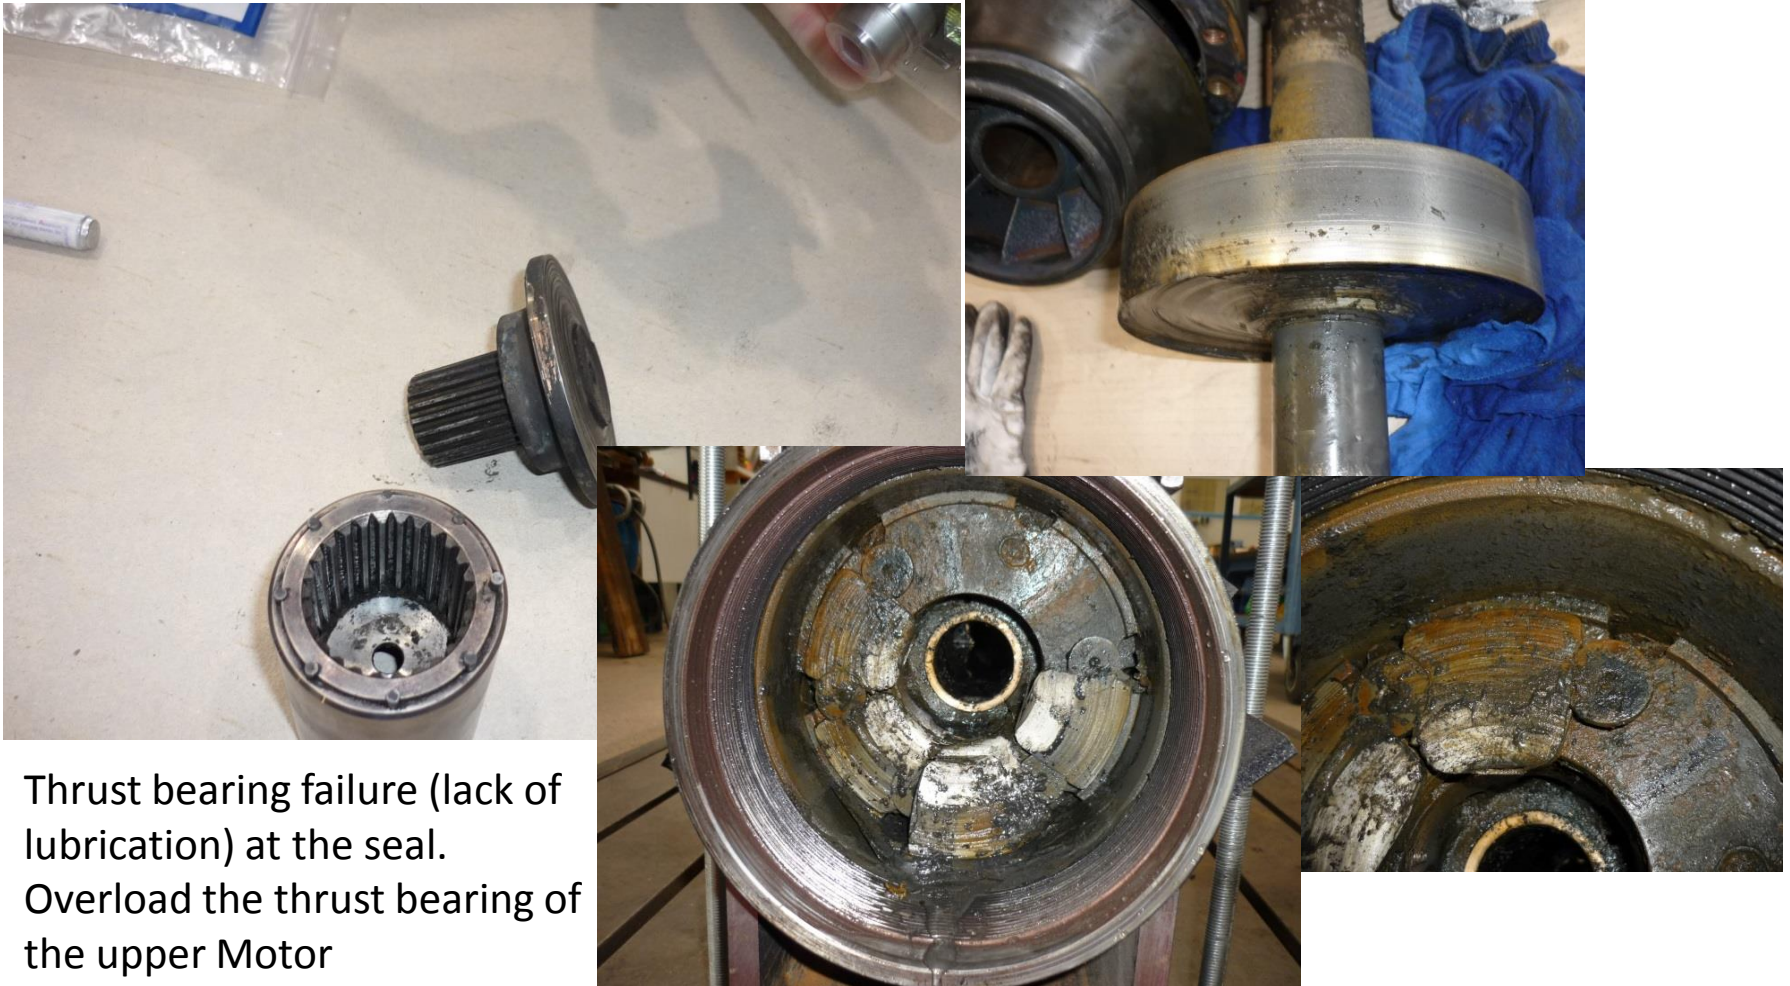
Thrust bearing failure (lack of lubrication) at the seal.
Overload the thrust bearing of the upper Motor

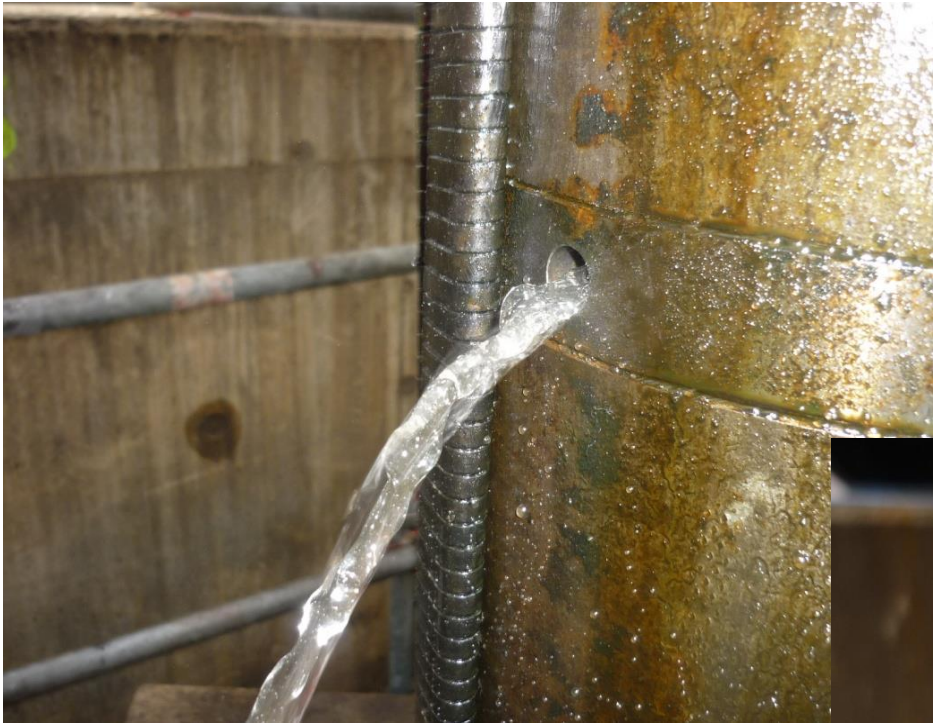
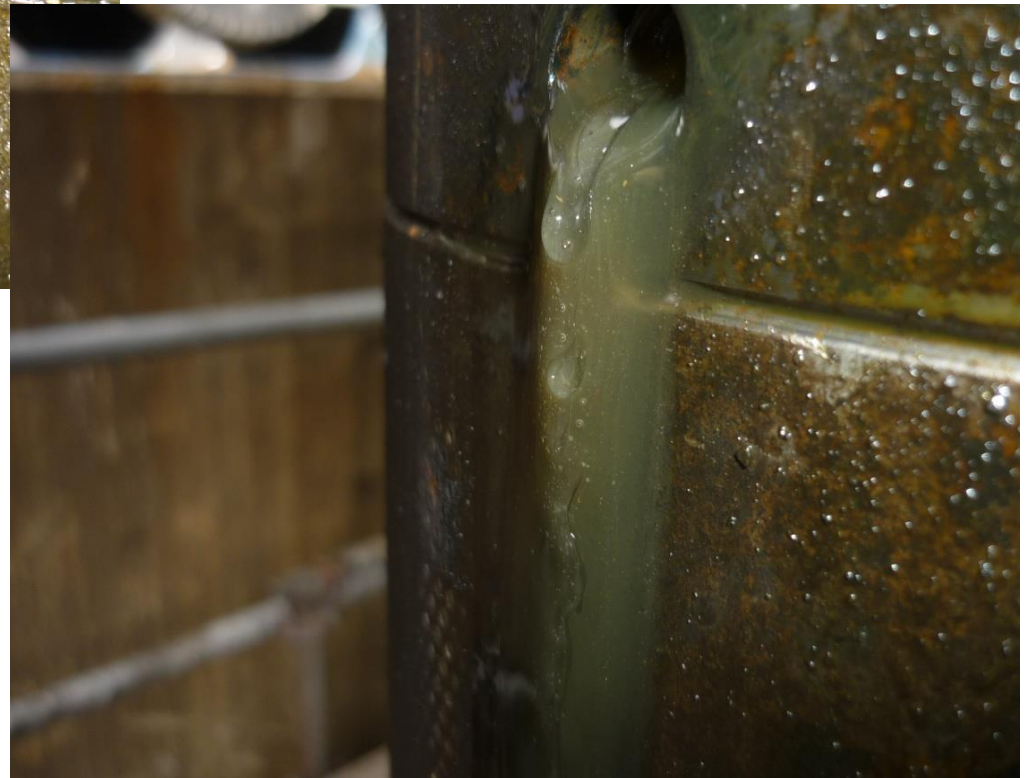
Geothermal water in upper chamber => O.K.

Water in lower chamber in the thrust bearing area => lack of lubricant.

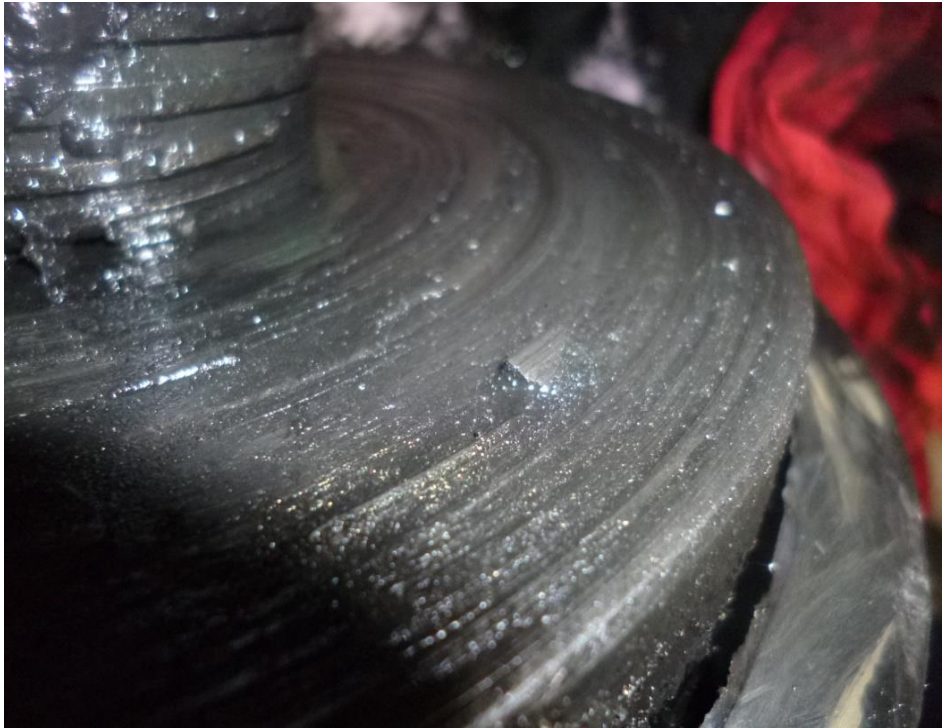
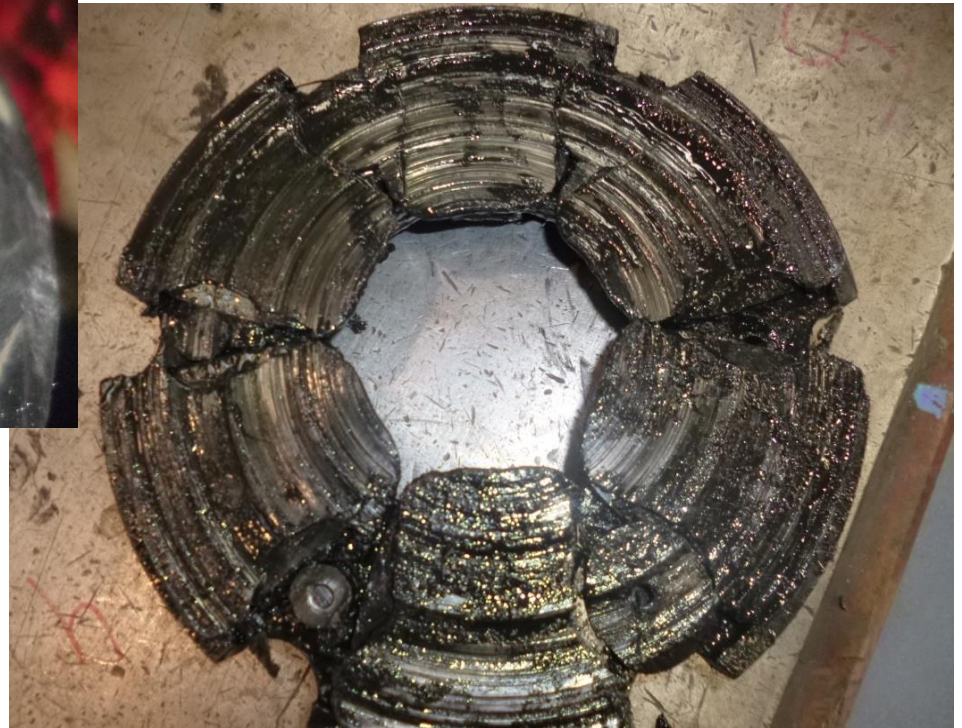
Running surface destroyed!

Thrust bearing segments are totally worn out.

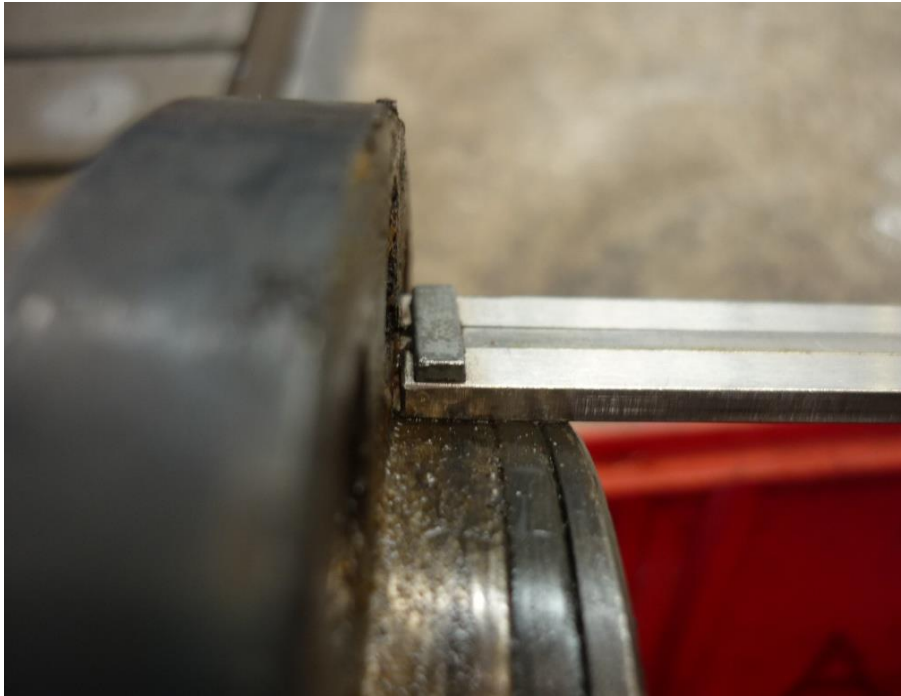
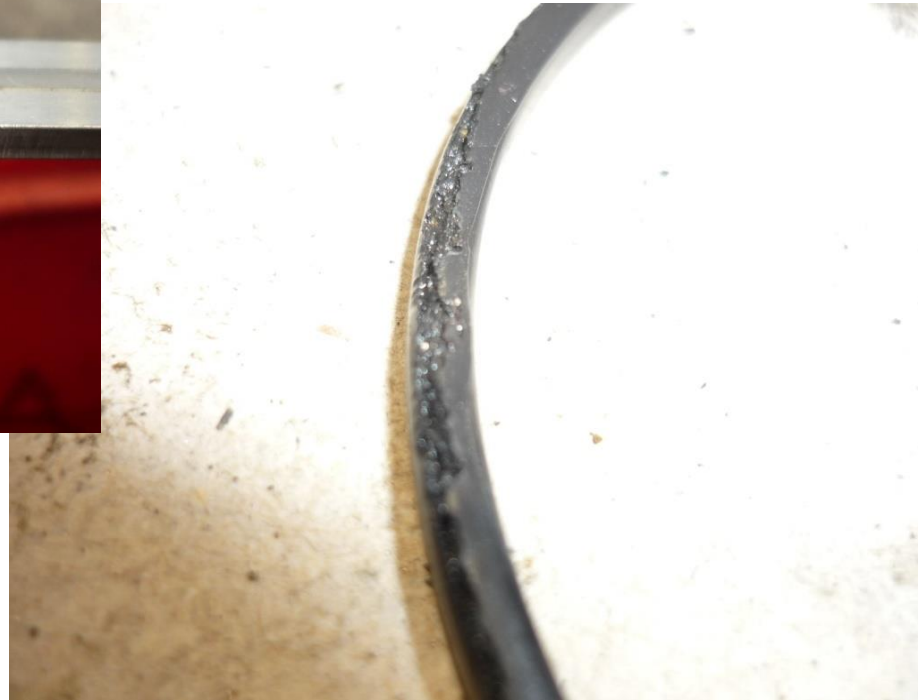
O-rings in case of thermal influence destroyed. Heavy weight oil $\rho \approx 1,9 \text{ kg/l}$ leaked out.

Flat and squared O-rings. Thermal influence caused a leakage.

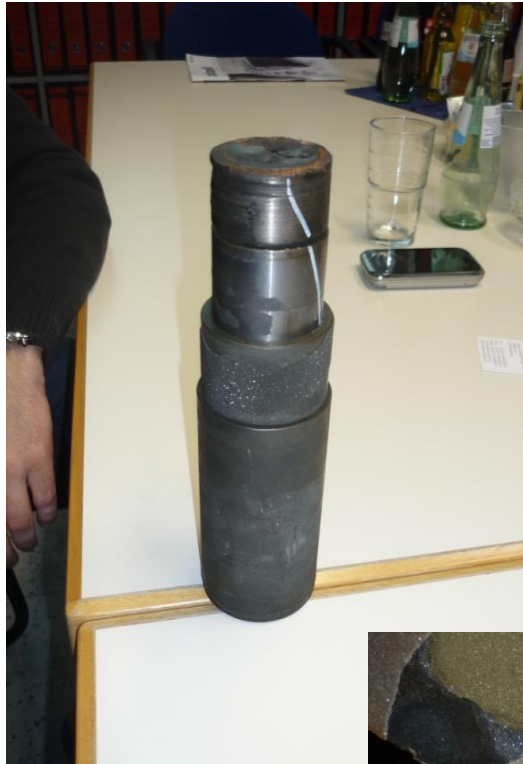
Broken shaft caused by a lack of lubricant (water).

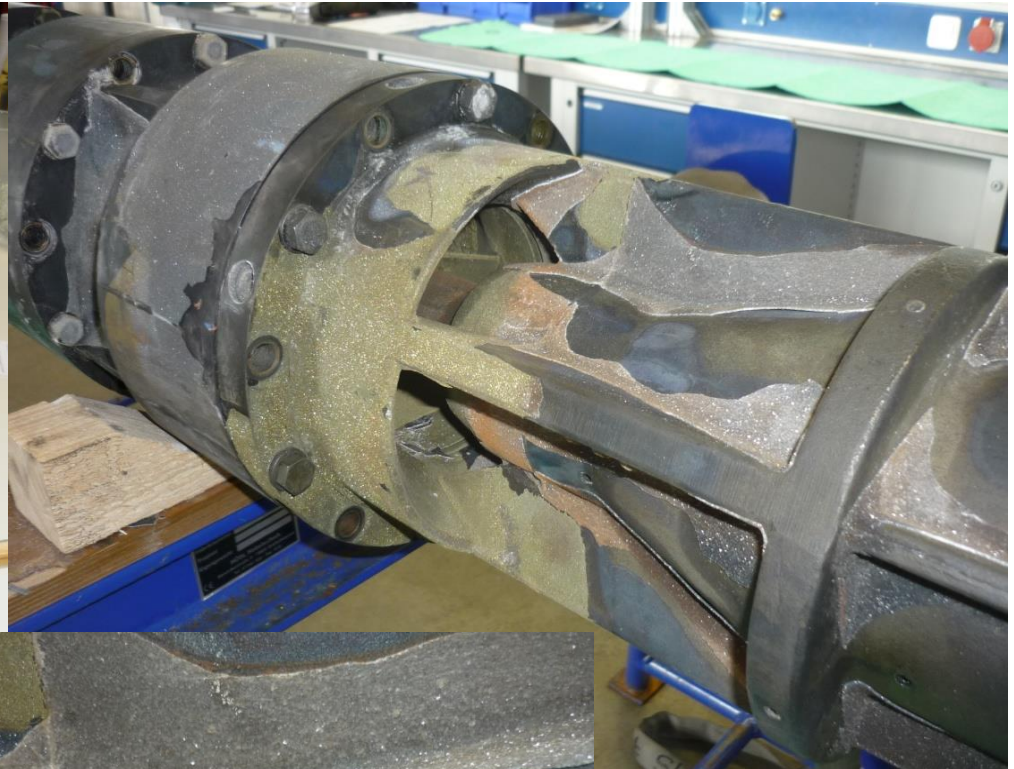
Heavy Scaling on „intake“.
Thermal discoloring in the bearing area.

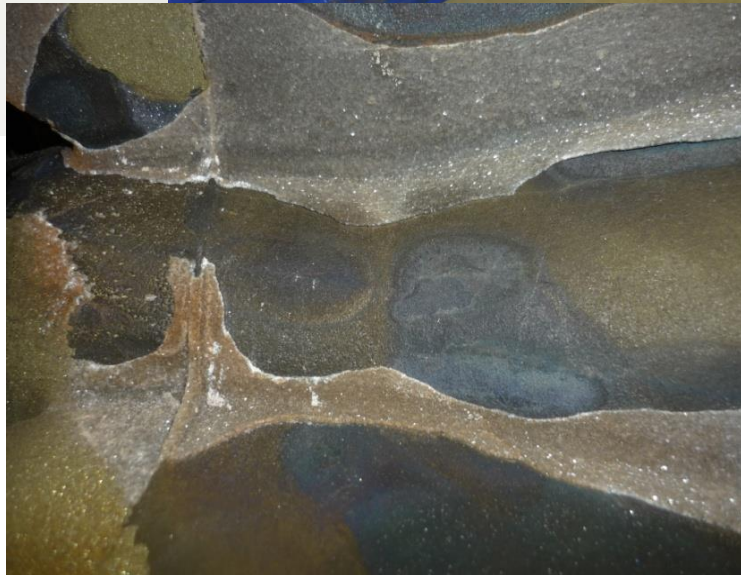
Lubrication and cooling bores clogged with scale.

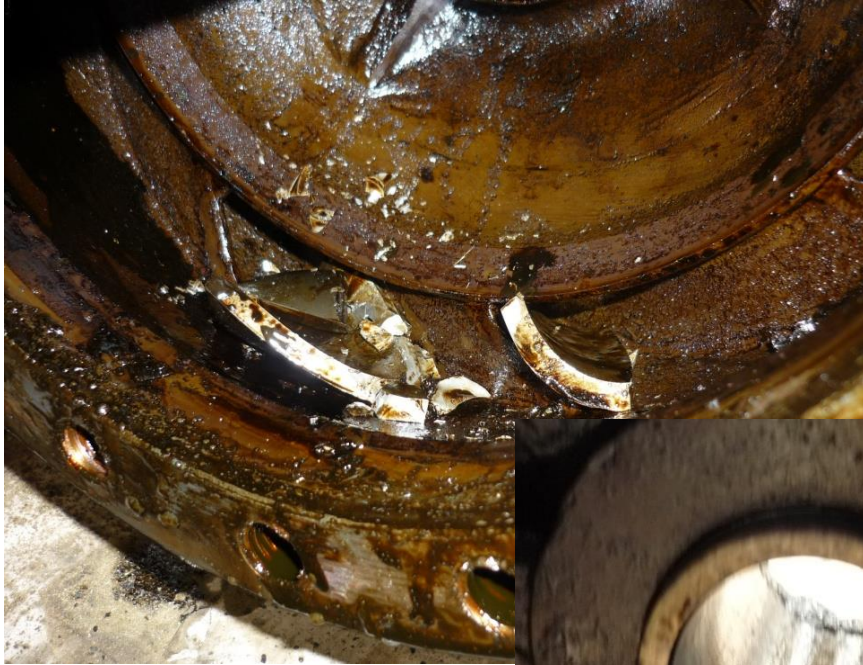
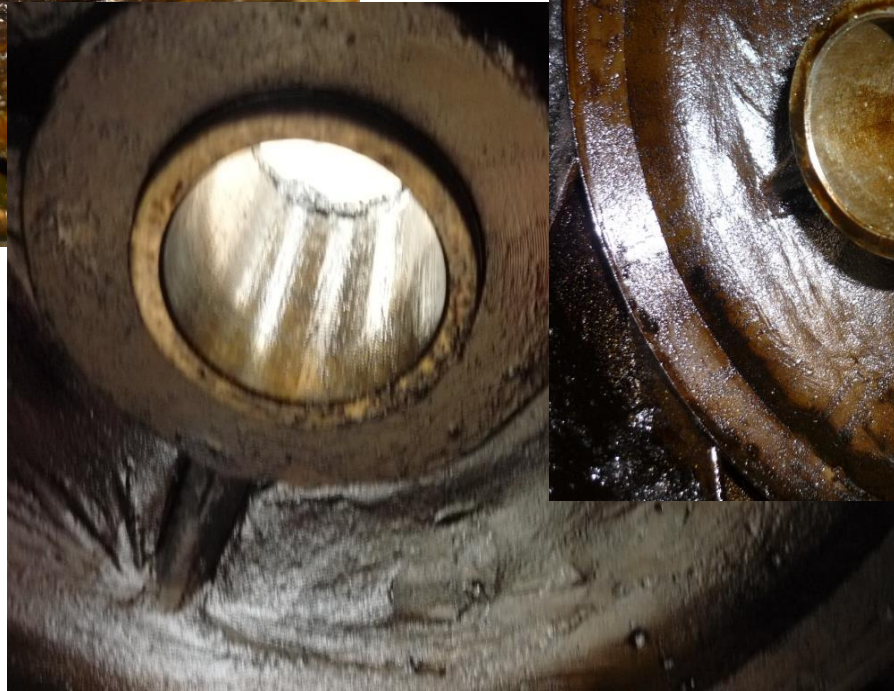
Missing radial bed
destroyed the WC
bushings.

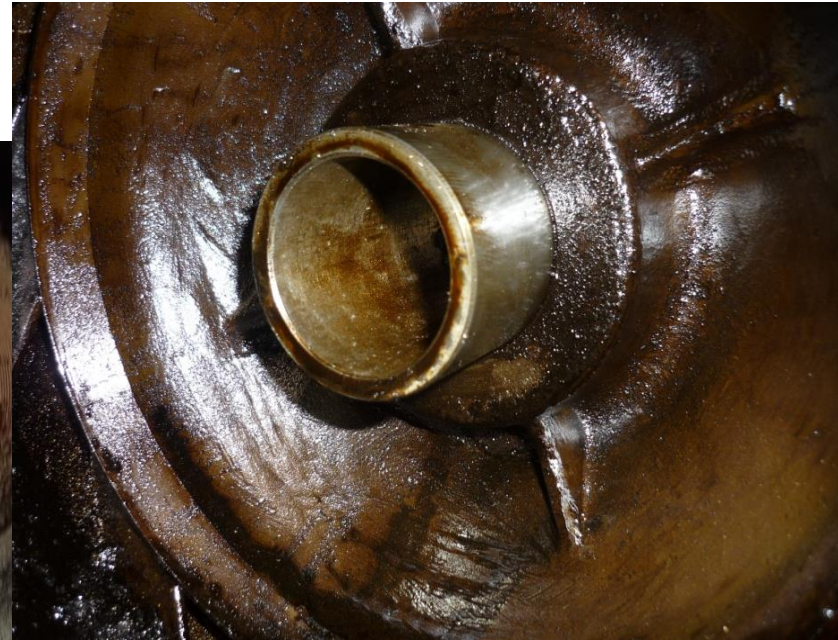
Bearing lost there axial position.

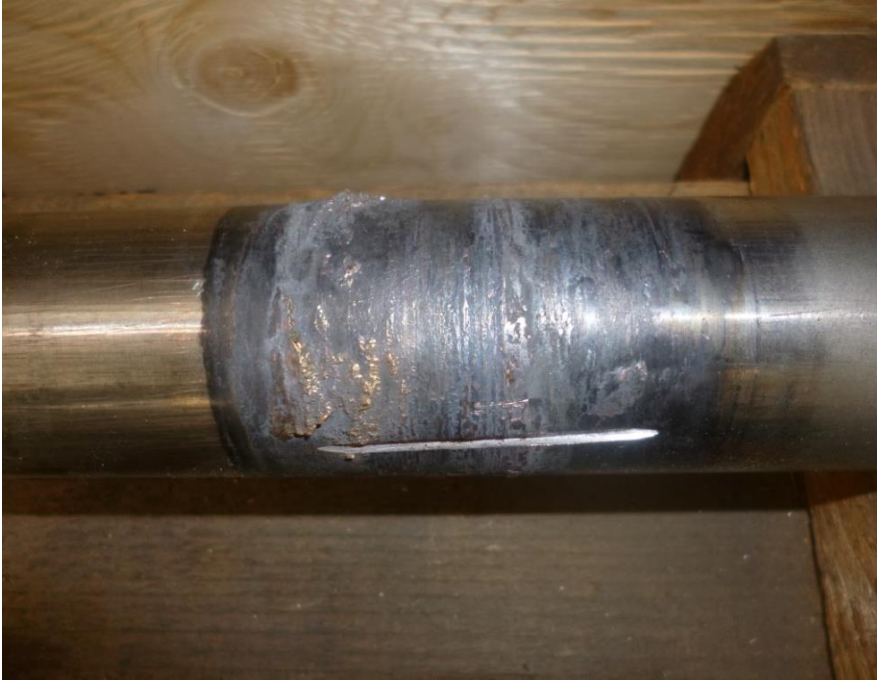
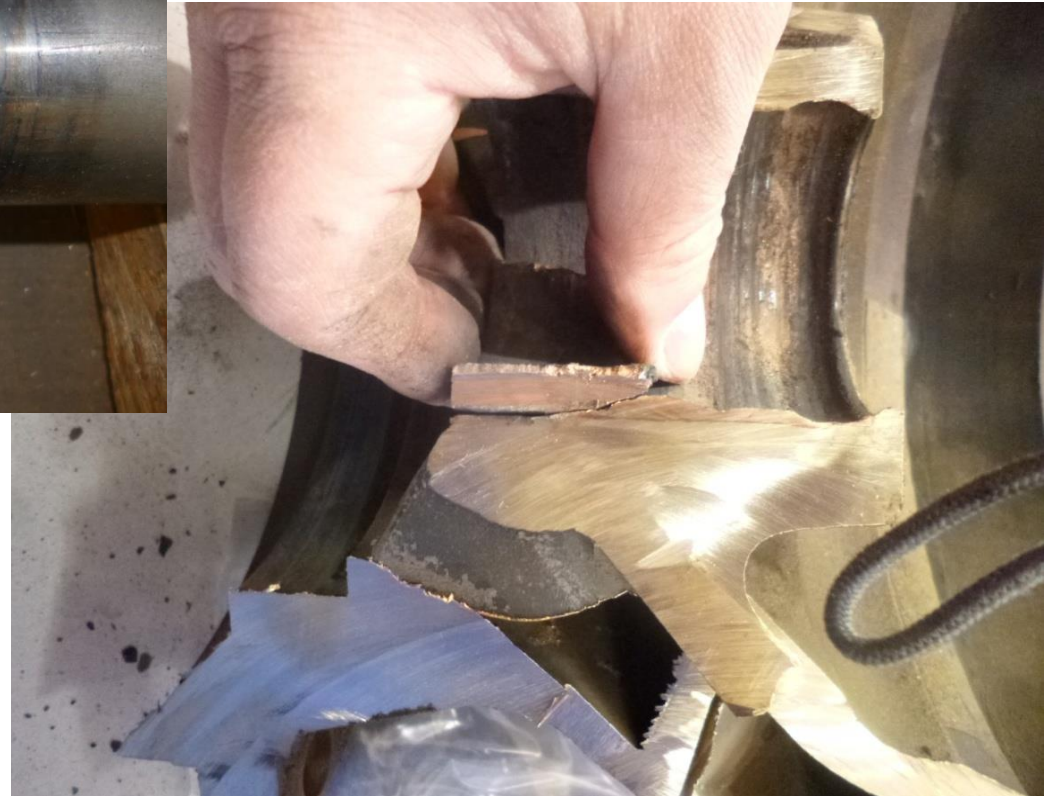
Bearing material melted with the shaft in the middle of the bearing surface

Bearing material splits axial and angular. Lot of puzzle cracks are visible. Overheating.
