Experience, solutions and development of operating geothermal ESP-systems in the southern Germany molasse reservoir.

Dipl.-Ing. Christoph Harden

High-Efficiency Geothermal Production Pumps Forum II

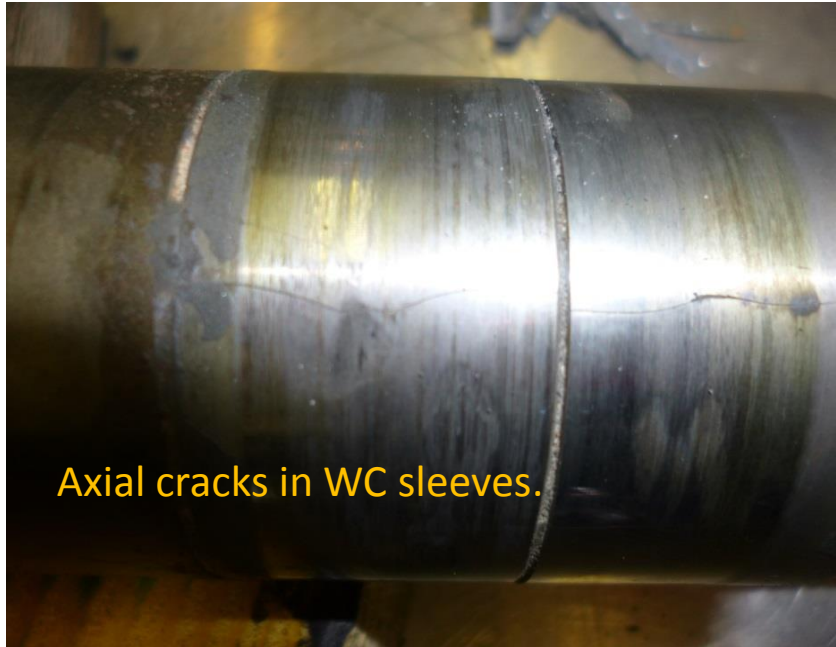
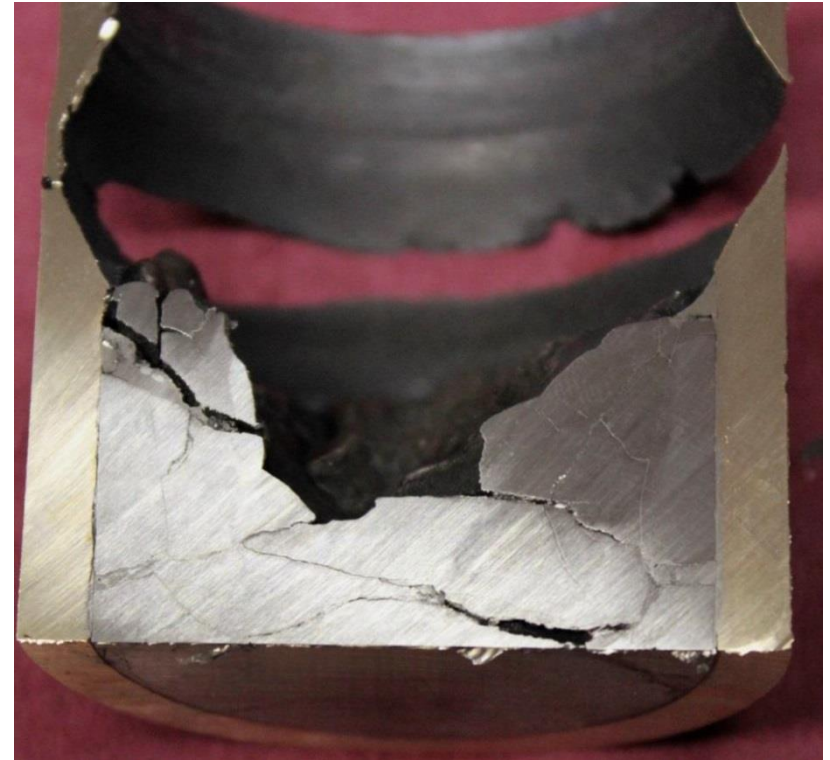
Shaft material brittle in consequence of liquid metal embrittlement from bearing material.

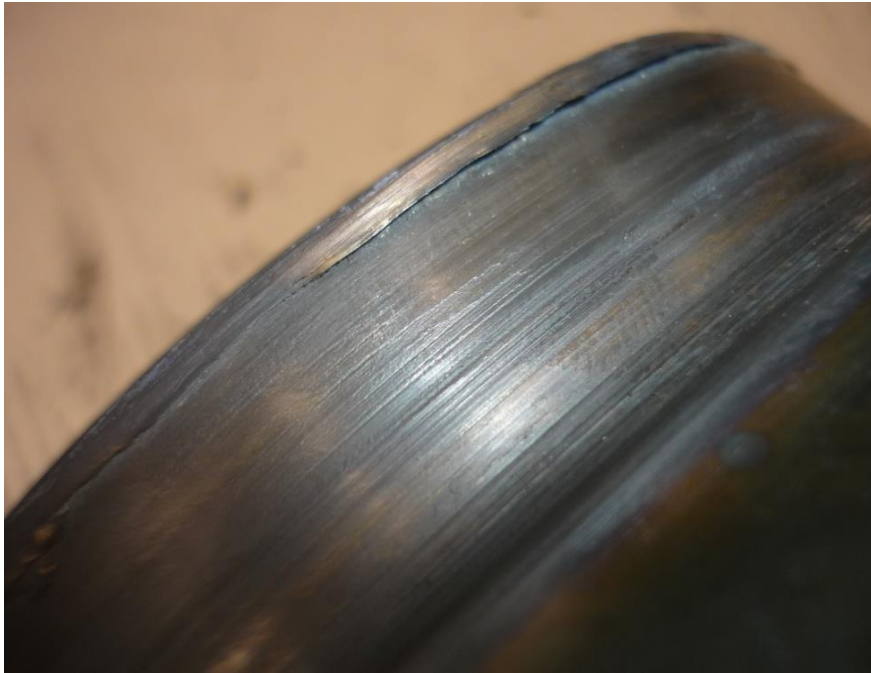
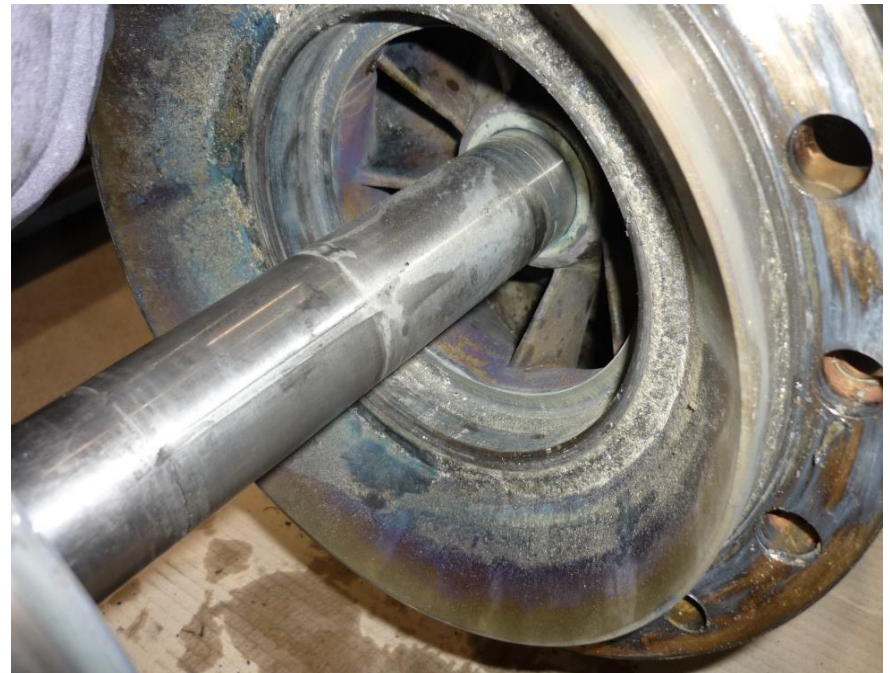
Melting material on the impeller seal surface.

Axial and radial rubbing of the impeller into the diffuser.
